**Flood Control Project Maintenance
Levee Inspections**

Fall 2013 Levee Maintenance Deficiency Summary Report

Reclamation District No. 0150 Merrit Island

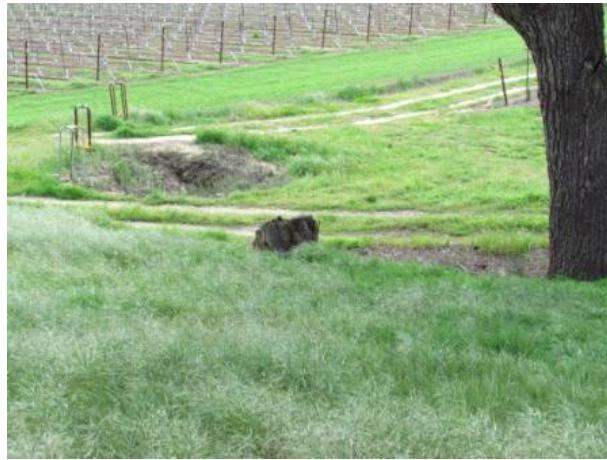
Levee Mile Report Line	110
Start Levee Mile	8.62
End Levee Mile	8.62
Location	Land Side
Category	Earthen Levee
Item	Trim / Thin Trees
A tree stump was found on the landside of the levee looking upstream.	
pkazi_f_20131001_715.jpg

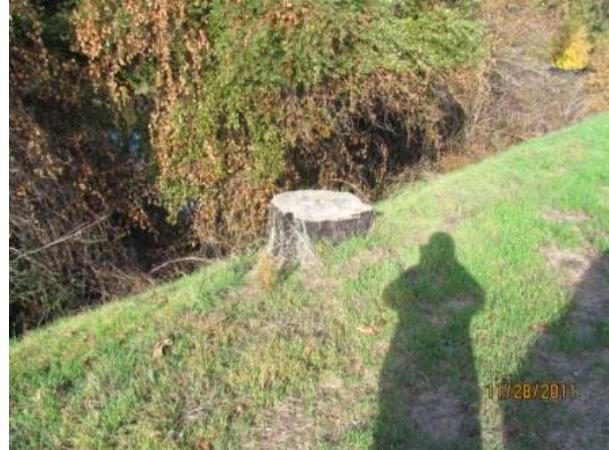
Levee Mile Report Line	111
Start Levee Mile	8.65
End Levee Mile	8.65
Location	Water Side
Category	Earthen Levee
Item	Trim / Thin Trees
A tree stump was found on the waterside of the levee looking upstream.	
pkazi_f_20131001_674.jpg

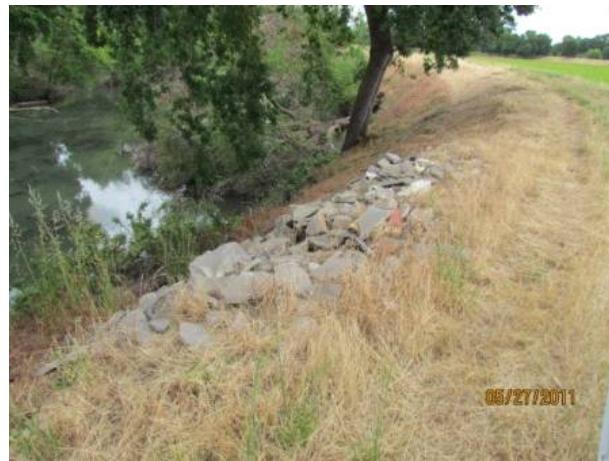
Levee Mile Report Line	112
Start Levee Mile	8.87
End Levee Mile	8.87
Location	Water Side
Category	Earthen Levee
Item	Encroachments
Broken concrete pipe was left on the waterside slope of the levee. The picture was taken from the crown looking upstream.	
pkazi_f_20131001_632.jpg

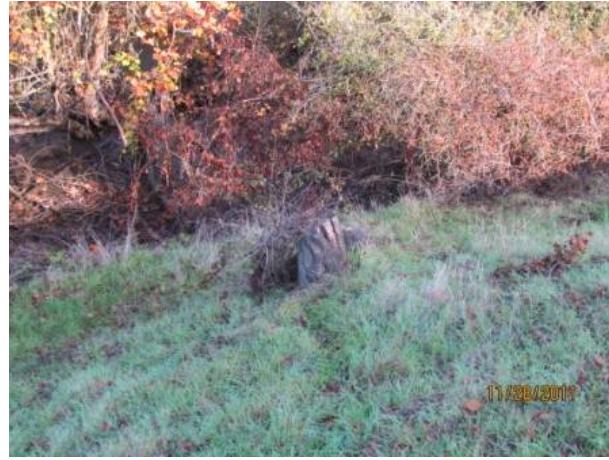
Levee Mile Report Line	114
Start Levee Mile	9.38
End Levee Mile	9.38
Location	Water Side
Category	Earthen Levee
Item	Trim / Thin Trees
A tree stump was found on the waterside of the levee looking upstream.	
pkazi_f_20131001_678.jpg

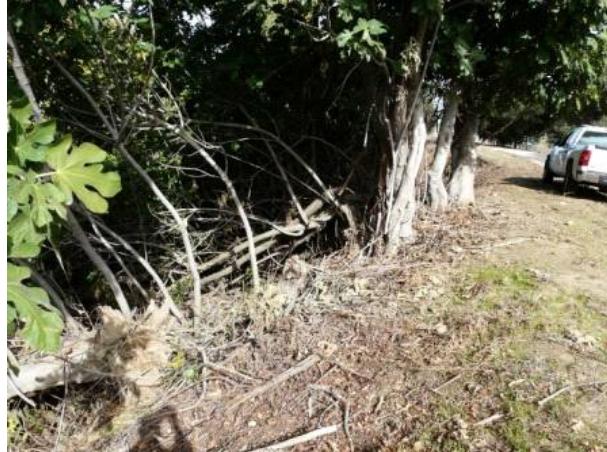
Levee Mile Report Line	115
Start Levee Mile	9.51
End Levee Mile	9.51
Location	Water Side
Category	Earthen Levee
Item	Trim / Thin Trees
Thin/trim trees to allow for visibility of top 20' of waterward slope at LM 9.51.	
pkazi_f_20131001_697.JPG

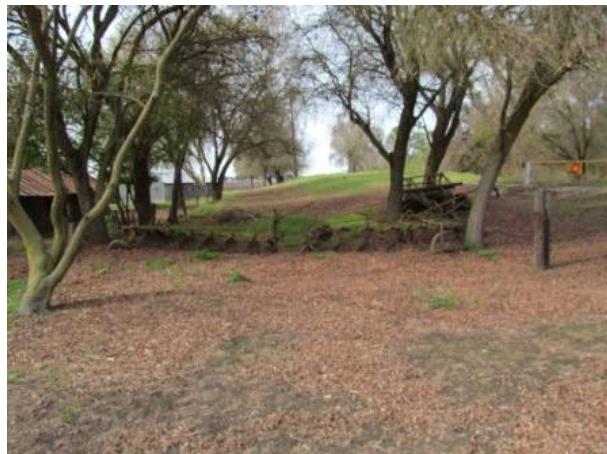
Levee Mile Report Line	116
Start Levee Mile	9.56
End Levee Mile	9.56
Location	Land Side
Category	Earthen Levee
Item	Encroachments
Equipment was found on the landside of the levee looking downstream.	
pkazi_f_20131001_729.jpg
